Photographs: ASH – Patient Units 1, 2, 3 & 4 Buildings

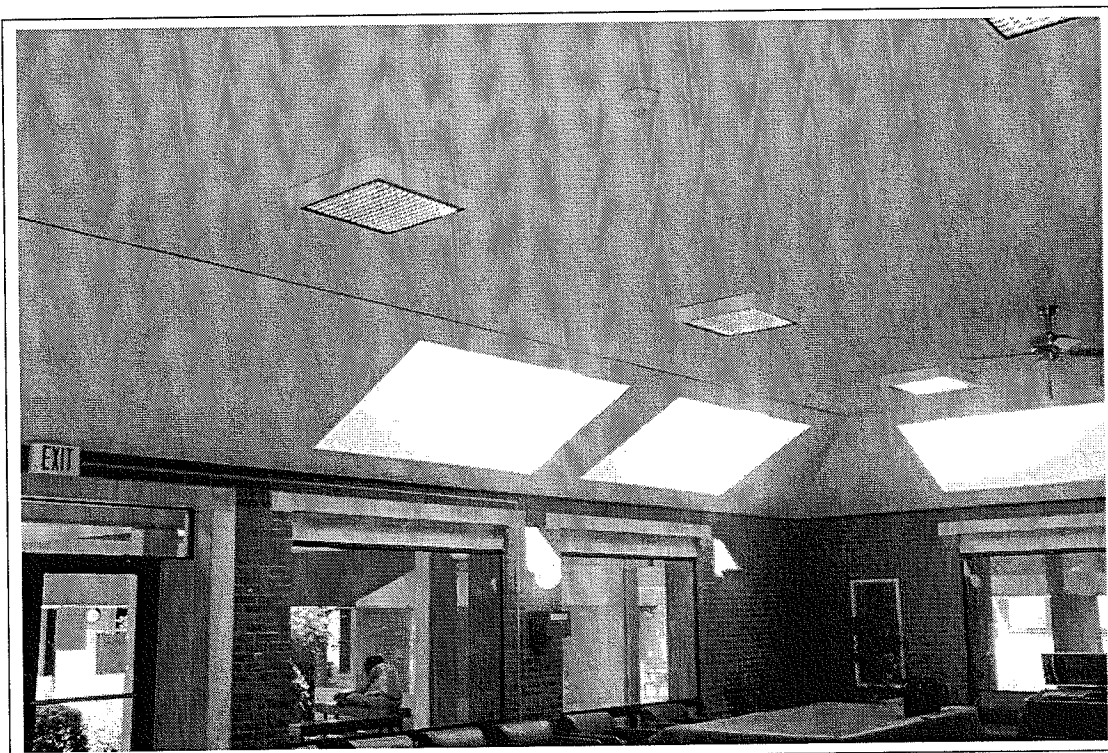
Photo 43. Unit 4 Recreational Area - General view of acoustical plaster ceiling

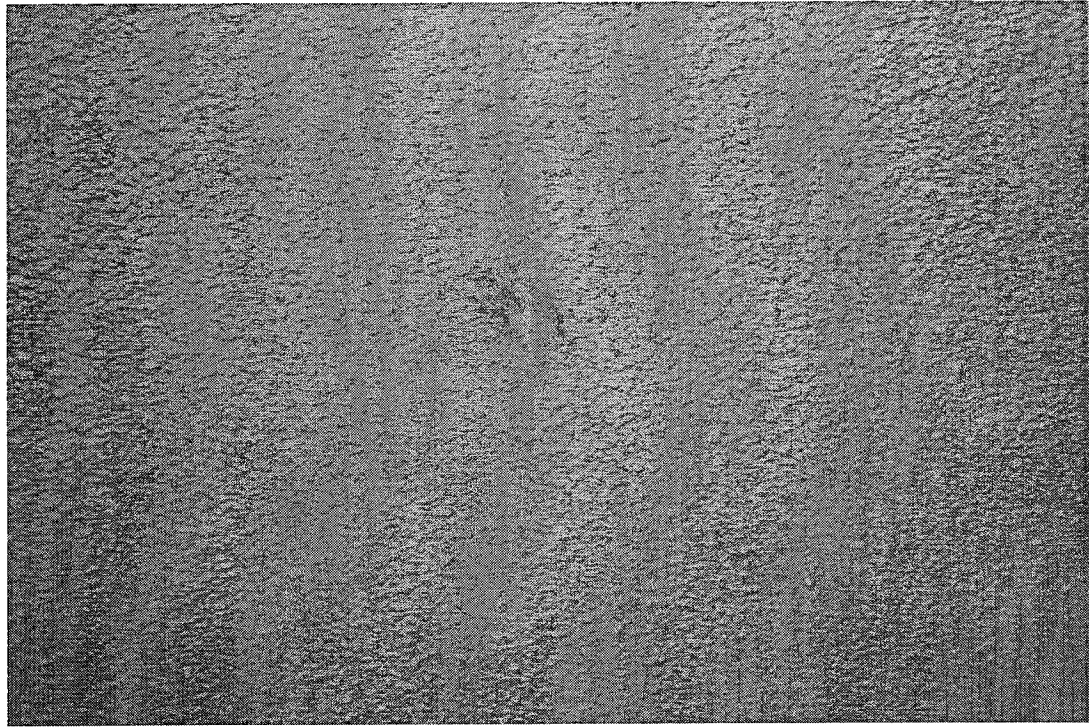
Photo 44. Unit 4 Back hallway at office area - Impact damage to acoustical plaster ceiling

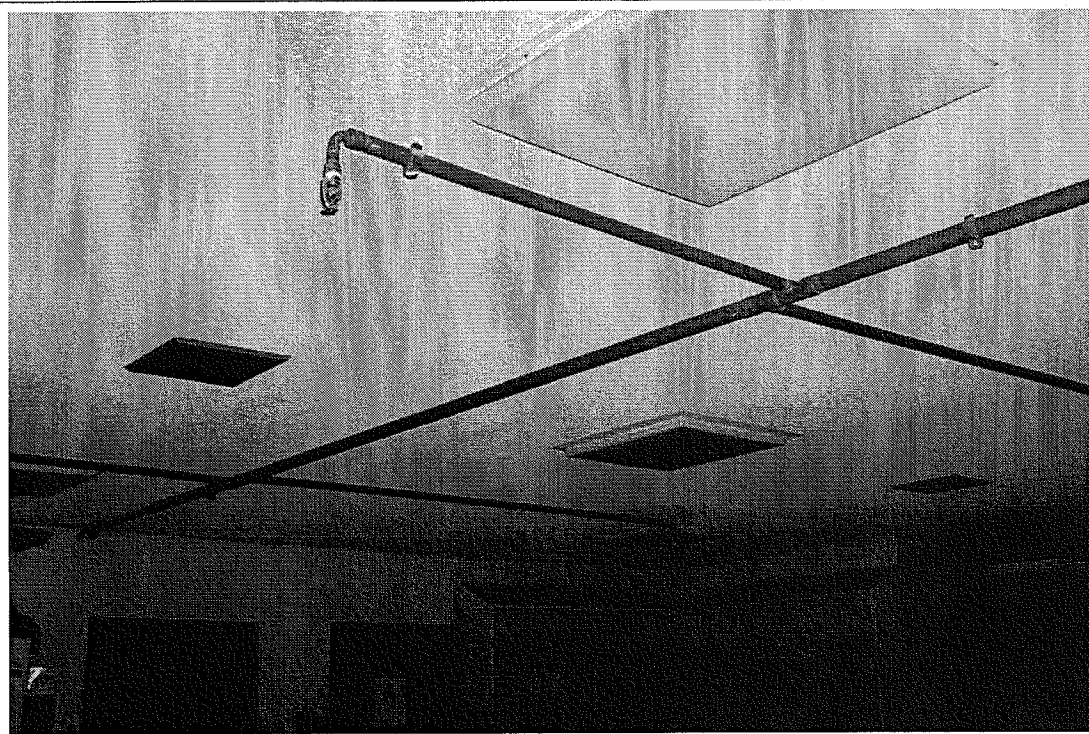
Photo 45. Unit 4 Upper patient area - Sprinklers attached to acoustical plaster ceiling

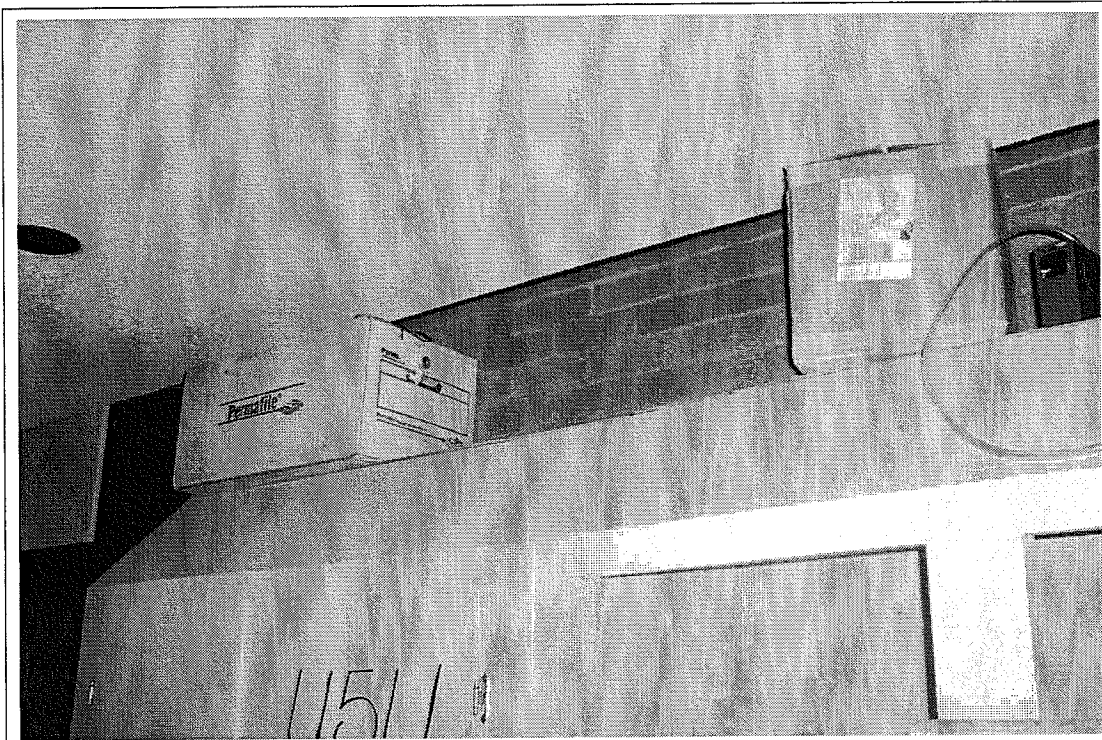
Photo 46. Unit 4 Quad A, Janitors storage area - Location of dust sample #2 (top of storage shelving)

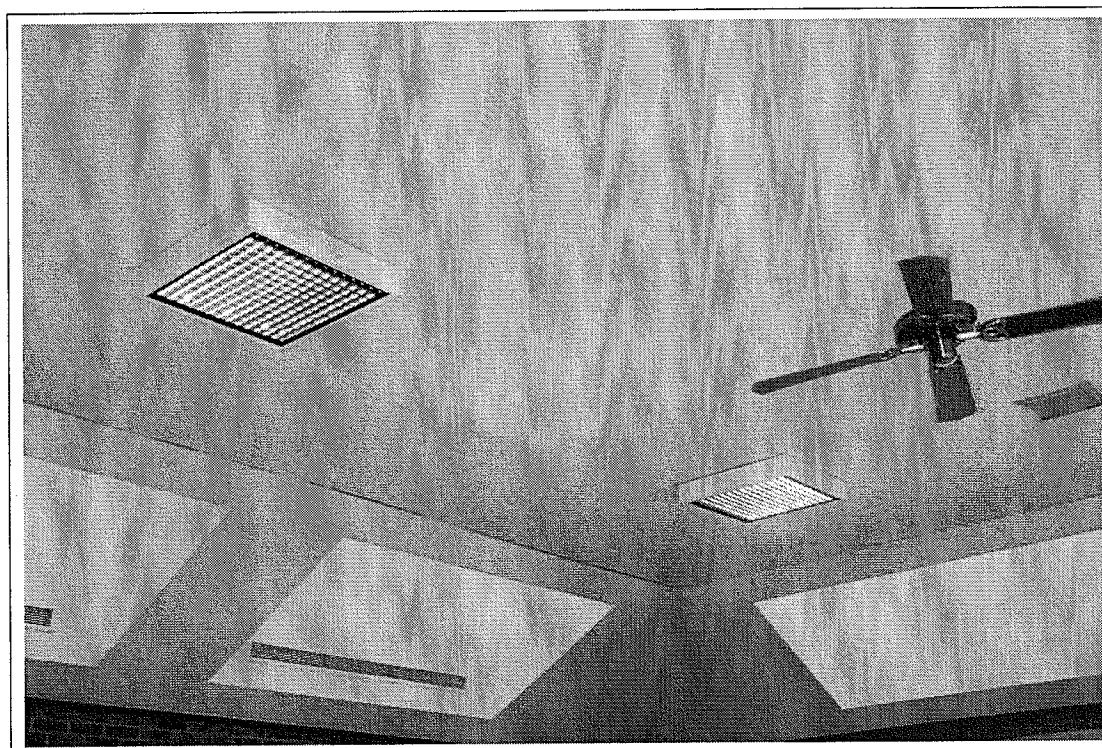
Photo 47. Unit 1 Dining Area - Patched area of plaster ceiling previously damaged

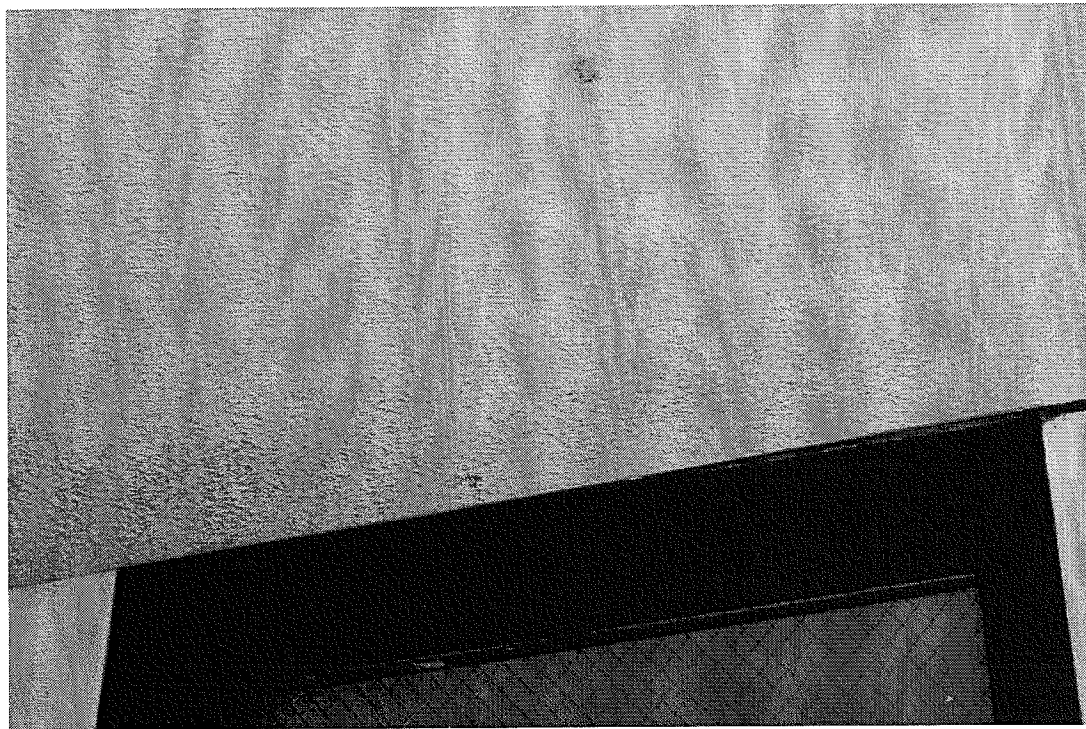
Photo 48. Unit 1 Upper Quad B - Impact damage above location of dust sample #1 (top of interior window ledge above store room)

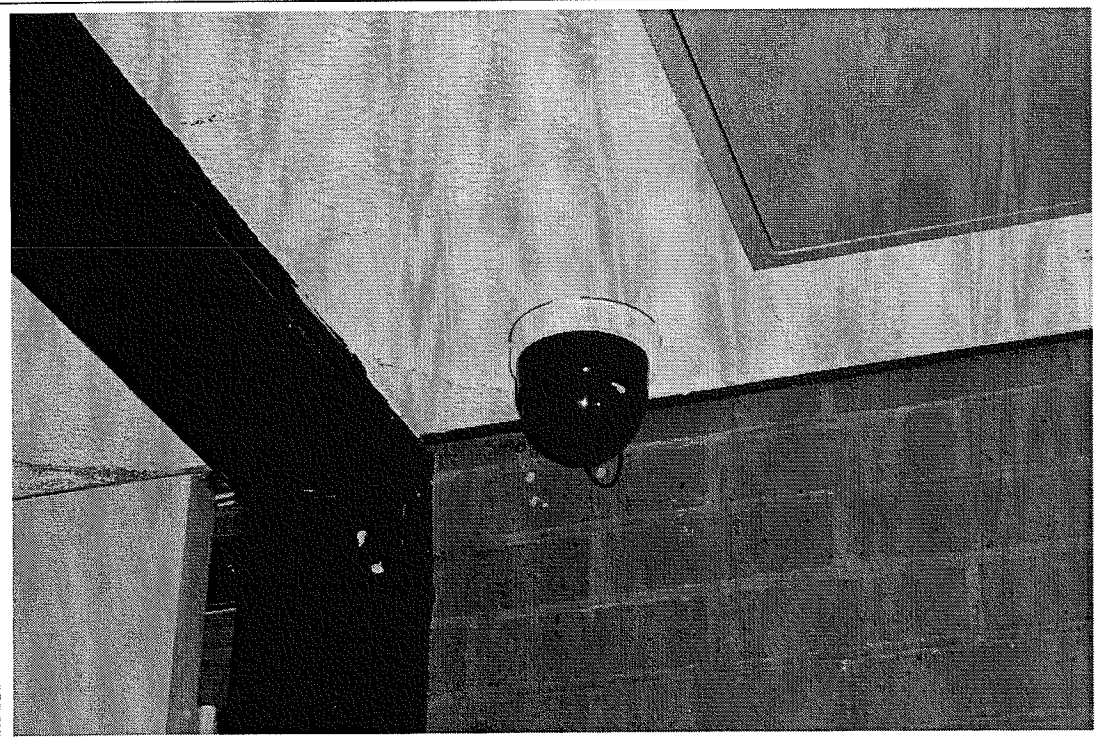
Photo 49. Unit 1 Hallway outside Upper Quad B – apparent spot abatement to acoustical plaster ceiling
